# PULSED PLASMA PROPULSION TECHNOLOGY

FINAL REPORT FOR PERIOD 10 MARCH 1972 - 30 MAY 1977

FAIRCHILD INDUSTRIES, INC.  
FAIRCHILD REPUBLIC COMPANY  
FARMINGDALE, N.Y. 11735

SEPTEMBER 1977

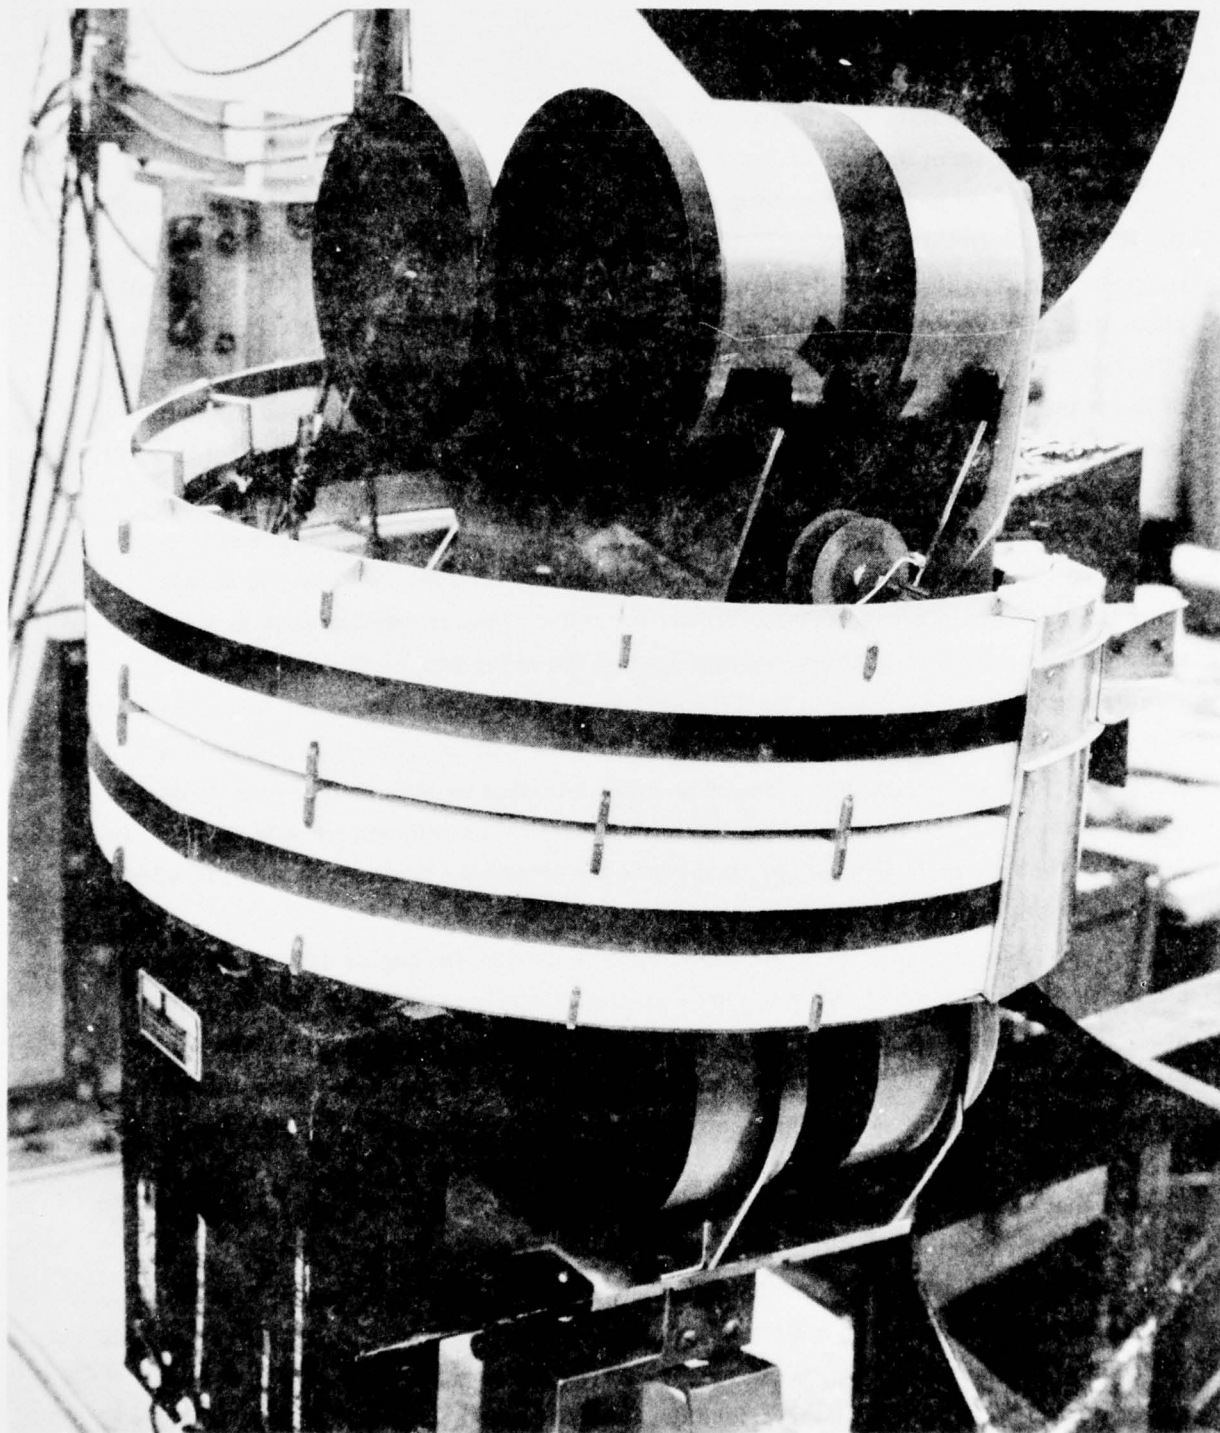
Figure 2. Photograph of Intermediate Thruster System With Mylar Capacitors

The purpose for running the thruster in this intermediate configuration was to begin generating long term data on the system as soon as possible so that any deficiencies could be identified prior to beginning the actual endurance test which would run using the KF-film capacitors being manufactured. In particular, new modifications to the propellant feed system were to be evaluated. These innovations consisted of physically separating the innermost propellant section from the middle and outer sections by a .04 inch (1.0mm) strip of aluminum mounted rigidly to the support brackets at the OD of the inner rod section, and using an independent separate spring to feed the outermost section. The .04 inch aluminum strip (referred to henceforth as the splitter rail) and the spring are evident in Figure 2. The purpose for the splitter rail, which penetrates about .06 inches (1.5mm) between the inner and middle propellant sections, is to take up the outward radial load induced by pushing the inner rod into the nozzle from the back end. It had been found during earlier experimentation (see Reference 4) that this outward force pushing directly against the outer two sections of propellant was causing binding because of the friction incurred. By separating the inner from the outer sections, the frictional force on all sections would be minimized and binding would hopefully be eliminated. Much the same situation existed between the middle and outer sections but the force pushing the middle section into the nozzle was considerably less than that on the inner section, and hence the frictional loading between the middle and outermost sections was considered to be a lesser factor.

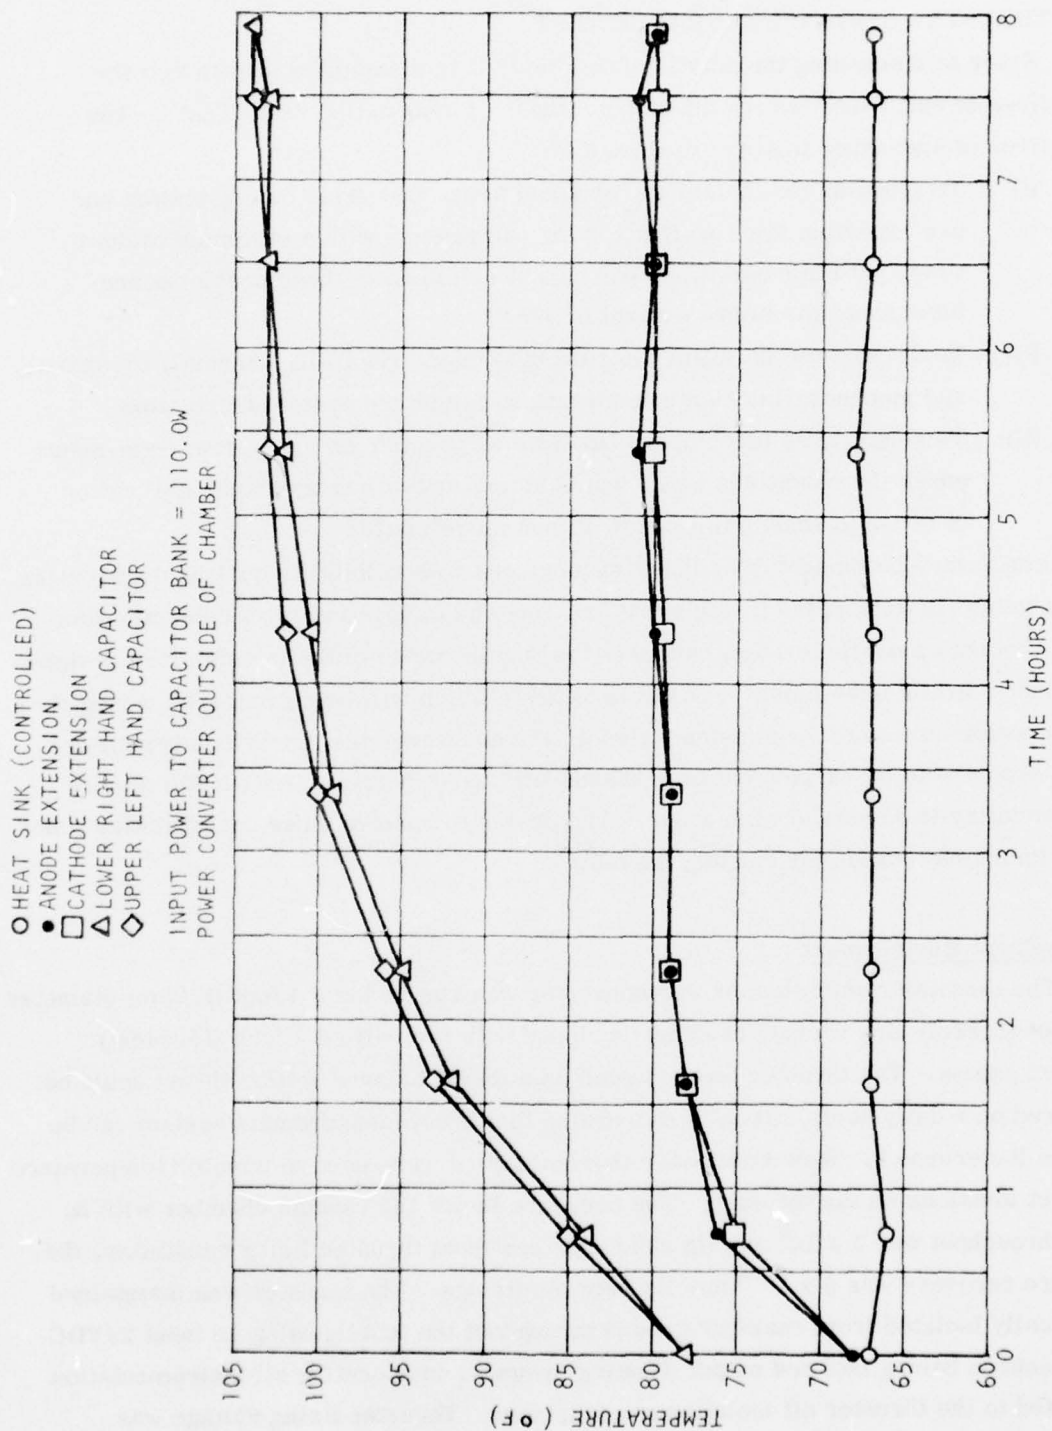
Figure 3. Results of Thermal/Vacuum Testing on Endurance Test Thruster System

The results of thermal vacuum testing are presented in Figure 3 where the temperature at various locations on the thruster is plotted as a function of time. The data of Figure 3 were obtained at a pulse rate of one firing every 6.8 seconds for a

net power output of 110W to the capacitor bank. Having assured the proper capacitor case temperature under normal operating conditions, the endurance test was initiated. Results of that test are presented in the next section of this report.

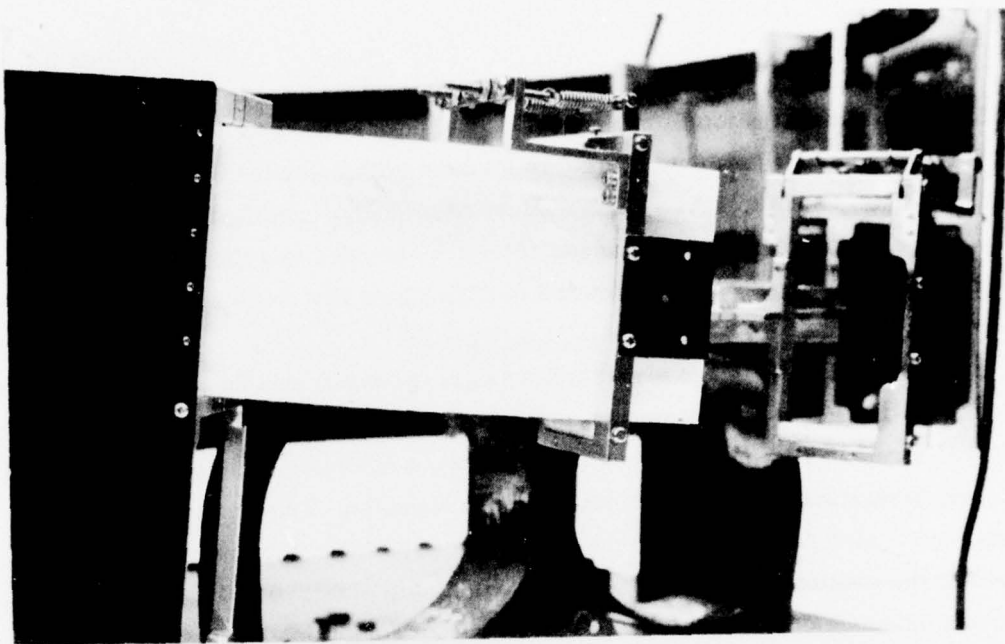
Figure 8. Spring Loaded Roller Assembly

Structural rigidity of the propellant support assembly was enhanced by redesigning the configuration of the center support and alignment ring. In addition, this main structural member was machined out of a continuous aluminum plate whereas it had previously been manufactured from NEMA G-10 phenolic. The propellant support brackets were also redesigned and machined from .25 inch (6.35 mm) aluminum as opposed to the original .125 inch (3.68 mm) aluminum plate. The brackets closest to the nozzle entrance on either side were fitted with a spring loaded Teflon roller to insure that the propellant rods would be pushed down onto the anode surface just prior to coming in contact with the fuel retaining shoulder while maintaining free motion of each propellant section under thermally expanded conditions. A photograph of this arrangement is presented in Figure 8.

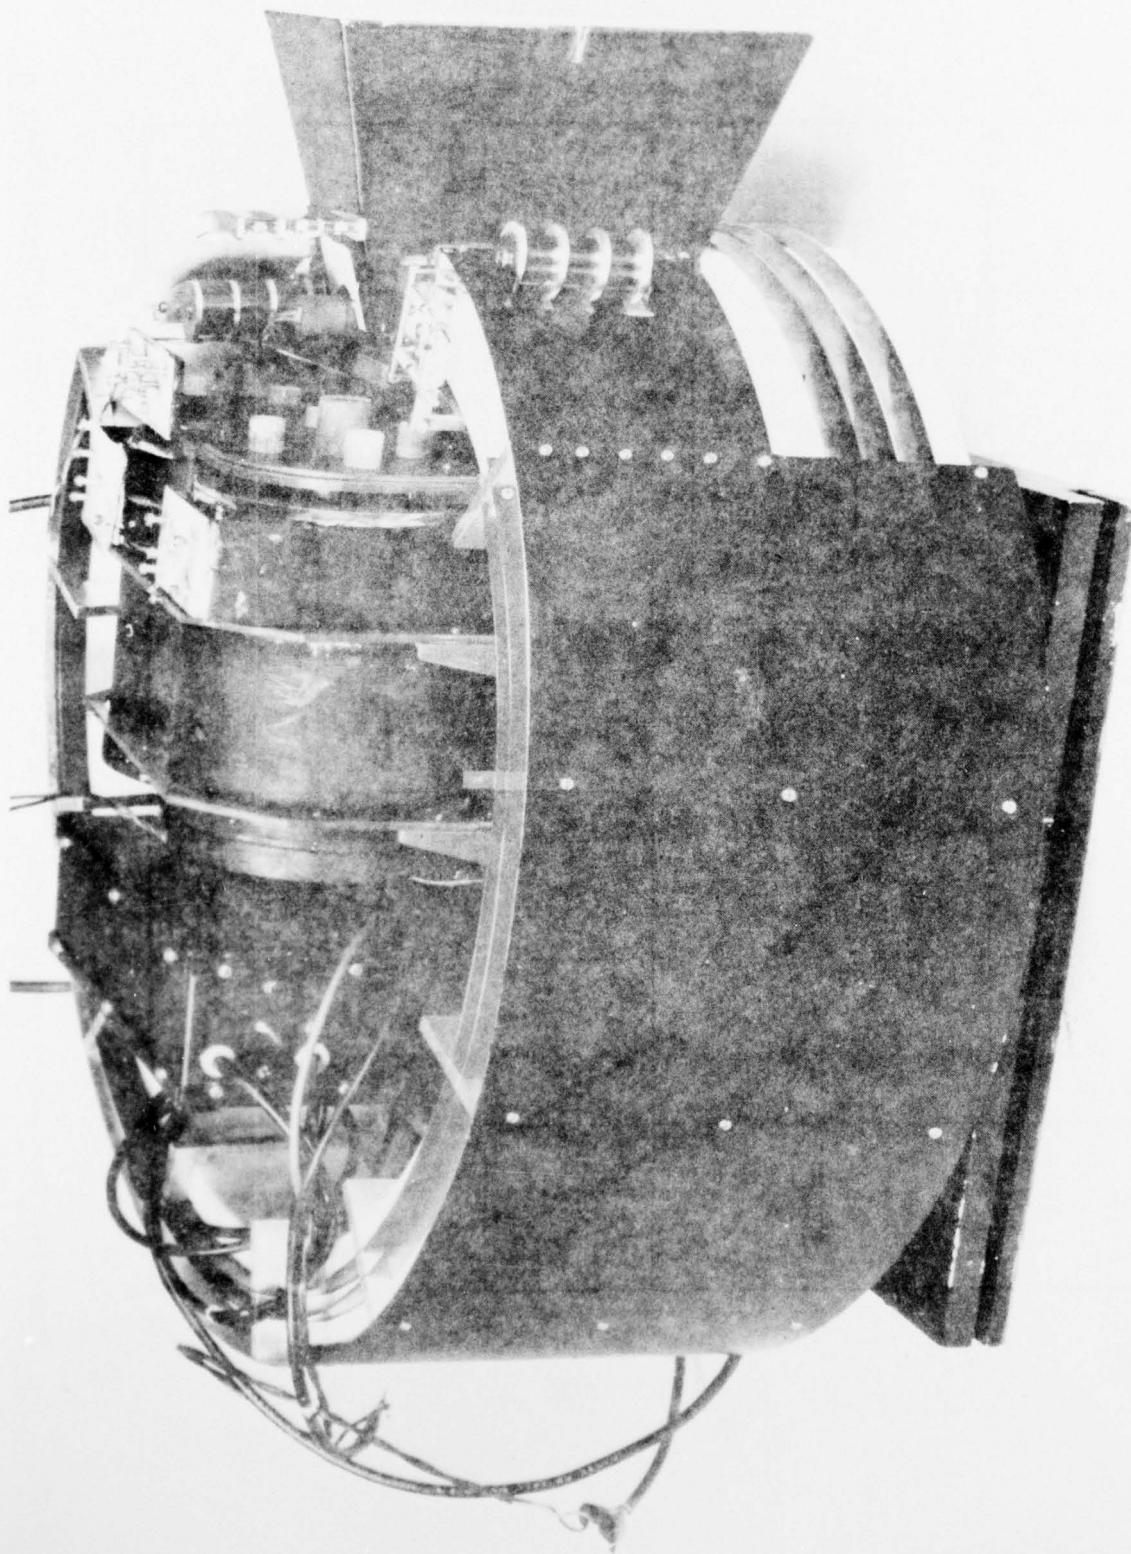
Figure 13. Refurbished Thruster System

Photographs of the completed refurbished thruster system are presented in Figure 13. Thermal vacuum testing of the complete system (including the refurbished power converter) was performed at Fairchild Republic and the results, presented in Figure 14, indicate completely compatible operation in vacuum.
